The price of (single point) failure

With two Boeing 737 MAX aircraft crashing in less than six months in seemingly identical circumstances and killing 346 people, there is a real sense that there is something wrong, not only with the aircraft design, but with safety culture at the company.

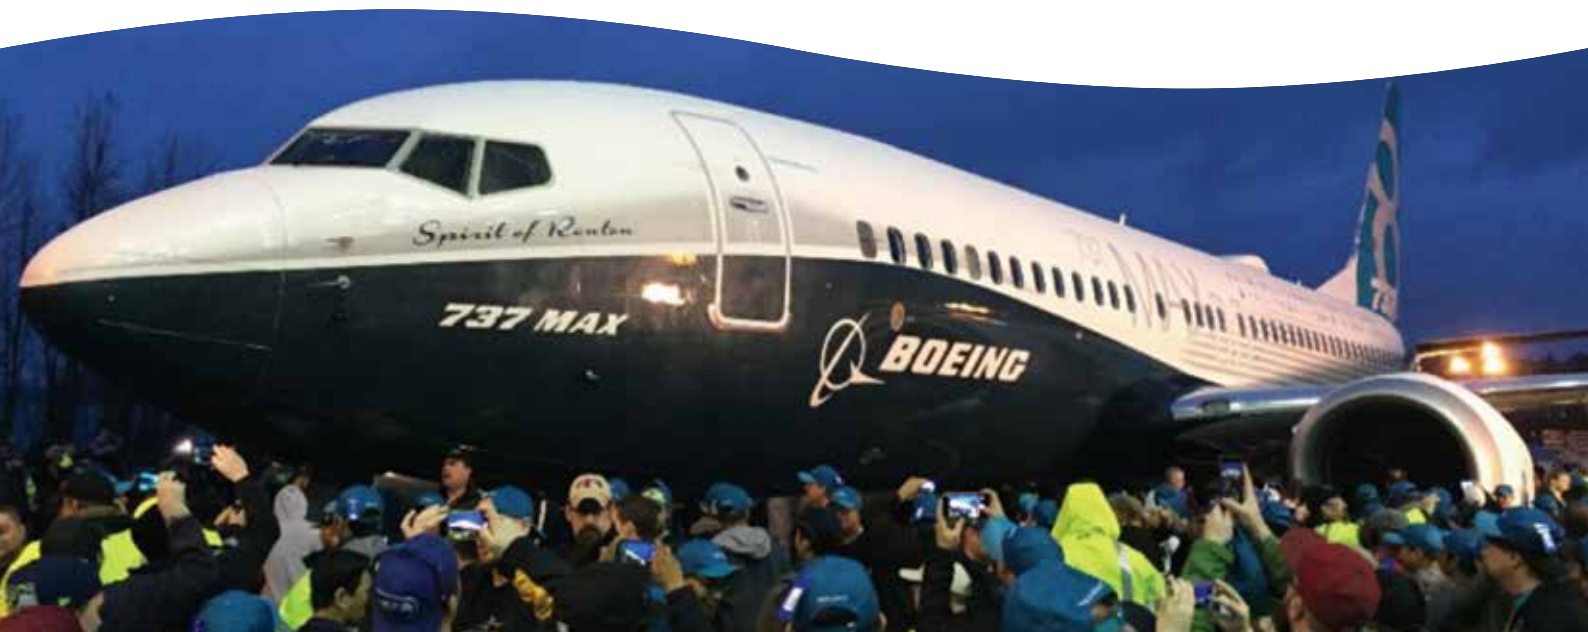
A brand new, additional flight system known as MCAS was therefore incorporated to run in the background, automatically adjusting the aircraft trim to ensure the aircraft handled in the same manner as earlier versions.

The incorporation of the new engines into the 737 MAX was not straightforward, on account of their sheer size in comparison to their forebears. The engines had to be mounted higher up and, as a consequence, further forward. This, critically, determined that under certain in-flight conditions the 737 MAX would tend to pitch upwards (Ref. 5).

A flaw in the configuration of the MCAS appears to be its reliance on data from a single Angle of Attack (AoA) sensor (Ref. 5), even though the aircraft is equipped with two such sensors. These AoA sensors provide a measure of the pitch of the aircraft against which, together with other relevant flight data, the MCAS dynamically determines and implements optimum trim of the aircraft. The MCAS, despite being critical to the safety of the aircraft, was not resilient to a single point of failure.
